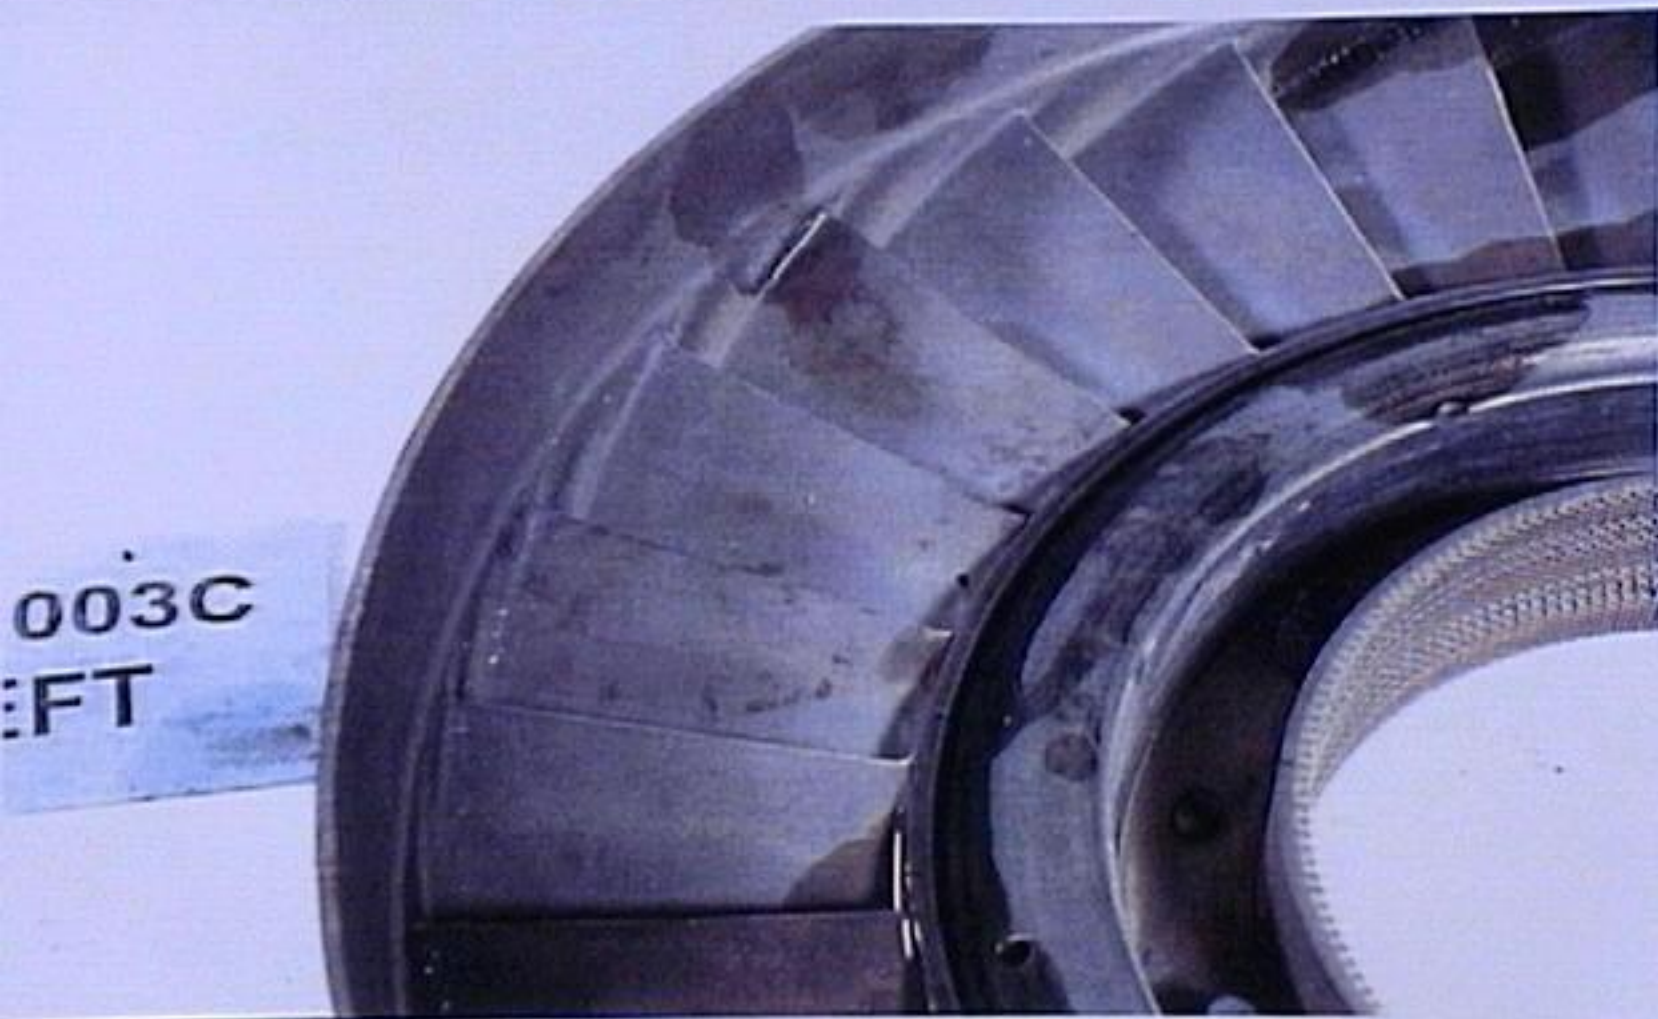
Figure 47. Metal Spray Deposits on the Third-Stage Turbine Stator Vanes
